Osaka  
Metropolitan  
University

# FEM Analysis of Reinforced Concrete Exterior Beam-Column Joint Structures Subjected to Highly Variable Axial Forces

工学研究科 都市系専攻 趙 能

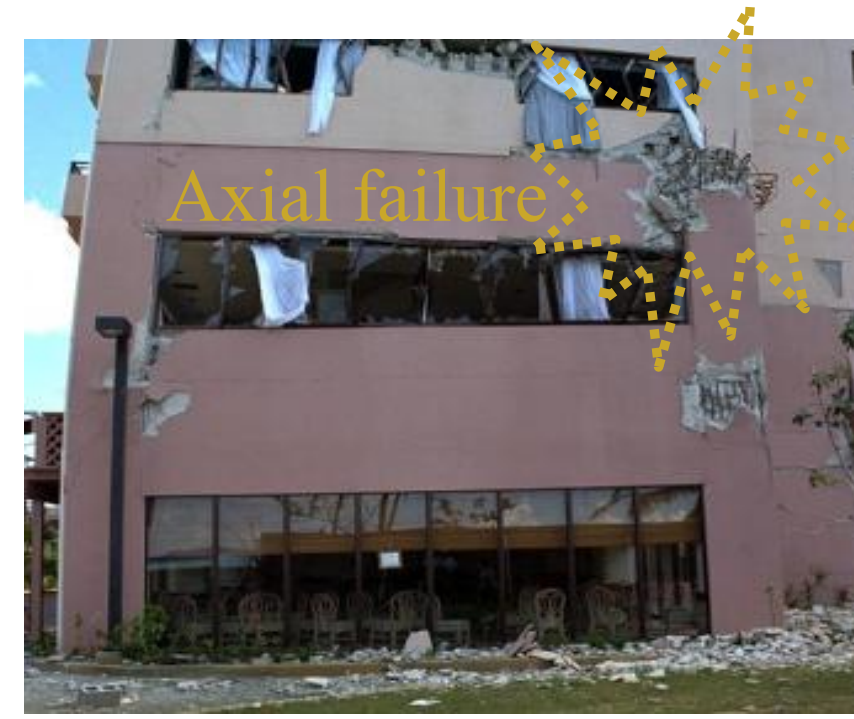
EQ damage from  
Guam Island Earthquake in 1993

In recent years, it has been reported that a type of damage known as axial failure occurs in the exterior column-beam joints in the lower stories of high-rise reinforced concrete buildings during earthquakes. This is due to the action of high fluctuating axial forces on the columns. To avoid building collapse during a severe earthquake, it is crucial to understand the mechanism that leads to axial failure in the exterior beam-column joints. This study aims to elucidate the axial failure mechanism in exterior beam-column joints by conducting a three-dimensional nonlinear finite element method (FEM) analysis. The FEM model is based on a previous experimental study involving exterior beam-column joint specimens subjected to high varying axial forces. The validity of the FEM model will be examined through a comparison of experimental and analytical results.
