A Study on Doubler Plate Method for Repairing Corrosion in Multiple Areas at Ends of Steel I-Girders

Osaka Metropolitan University Graduate School of Engineering Bridge Engineering Lab Taishi INOUE

To elucidate optimal doubler plate shapes for end corrosion in steel I-girders

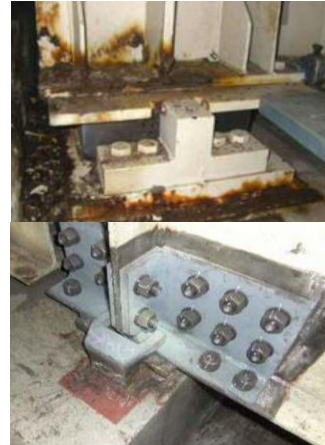
Fig. 1 Corrosion Damage and Doubler Plate Repair

- ✓ The ends of steel I-girders are prone to **corrosion**. As shown in Figure 1. Repairs of these corrosion using high-strength bolts have been carried out. However, since **various forms** of corrosion damage have been observed, the cost of inspection and repair design for all cases may be **very high**.
- ✓ It is expected that the repair design process can be **simplified or omitted** by elucidating the shape of cover plates that can accommodate various forms of corrosion.

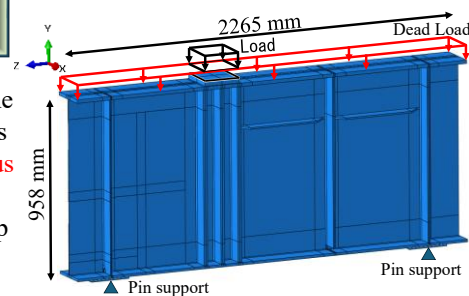
The model shown in Figure 2 was used in the analysis. The repair using doubler plates was studied under the assumption of **simultaneous corrosion at the bearing stiffeners** and at the end side of the web, where a significant drop in maximum load occurs. In this form of corrosion, the maximum load capacity is reduced to **22%** of that of the intact condition.

Fig. 2 Analysis model

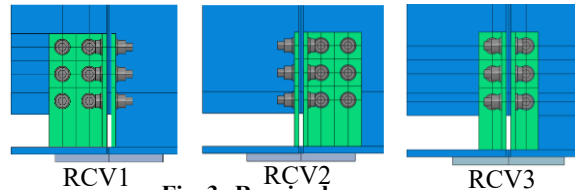
Three cases with different shapes of the plate as shown in Figure 3 were considered. However, the number of bolts and cross-sectional area are the **same in each case**.

Fig. 3 Repaired case

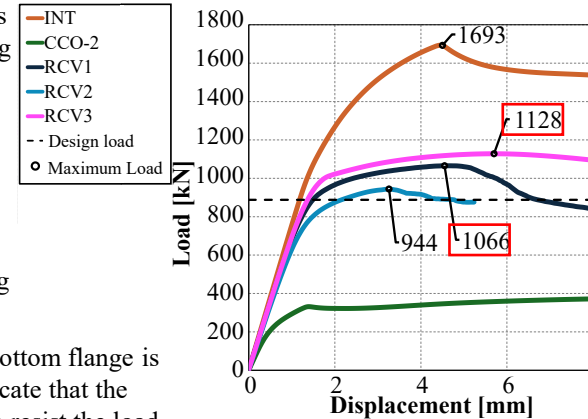
- As shown in Figure 4, It was confirmed that RCV3, which repairs the area closest to the bearing where the support reaction force acts, is **the most** effective repair method.
- The **same level** of recovery effect was also confirmed in the case of repairing primarily the web on the girder end side.
- This may be due to the use of **angle materials** in RCV3, which resulted in a large second moment of area of the plate, and in RCV1, which reduced the bending of the plate by controlling the **lifting of** the lower flange.
- In RCV2, as shown in Figure 5, the bottom flange is observed to be lifted, which may indicate that the plate has bent and is no longer able to resist the load.

Fig. 4 Load-displacement curve

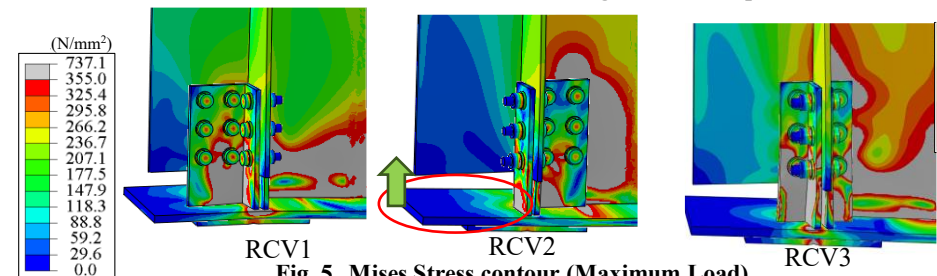
Fig. 5 Mises Stress contour (Maximum Load)

1. In the case of the doubler plate repairs studied in this research, the maximum load is reached when the **doubler plates** can no longer resist the applied load.
2. Since **bending** occurs due to flange lifting, it is desirable to adopt repair methods that can **suppress** this behavior.
